Manhole Inspection Summary

Manhole # S3900_005MH

Location Address: **2068 KENNEDY AVE**

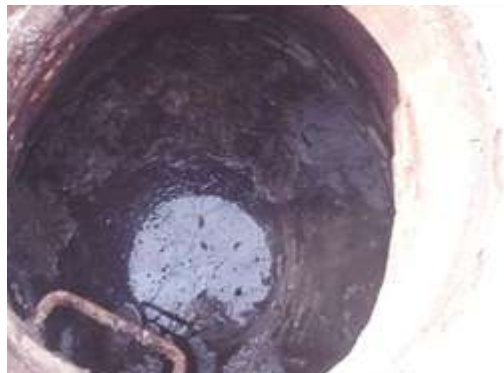
Top View

Corroded steps. Channel debris.

Active surcharge - 1st visit.

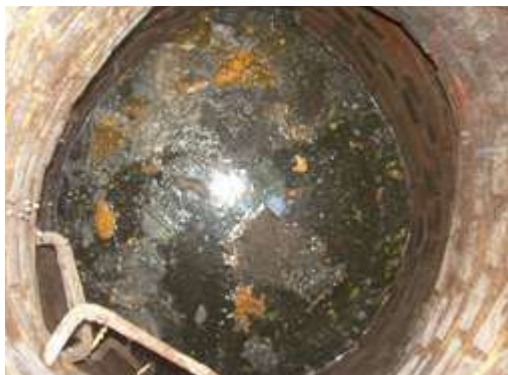
Defect

Frame leaks. Frame offset. Adjustment deterioration and infiltration.

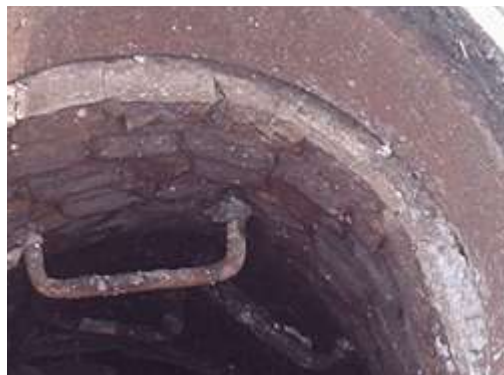
Defect

Frame leaks. Adjustment and Corbel deterioration and infiltration.

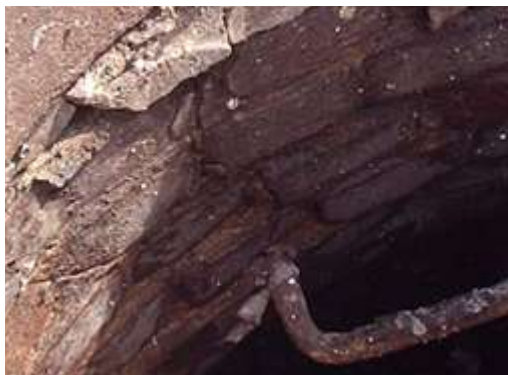
Defect

Adjustment and Barrel infiltration.

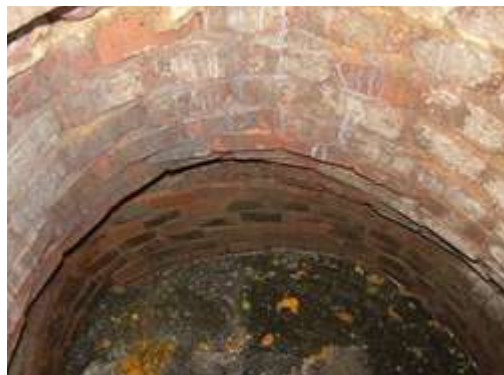
Defect

Barrel infiltration.

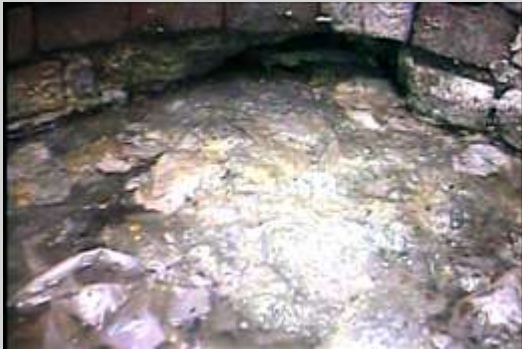
8 in. Circular Gravity Sewer Pipe Out @ 12 O'Clock

Deposits: ☐ None ☒ **Mud** ☐ Sludge ☒ **Debris** ☒ **Grease**

Silt Depth: **7** (in.) Deposits Extent: **Heavy**

Infiltration: **Evidence** Pipe Seal Cond: **Broken**

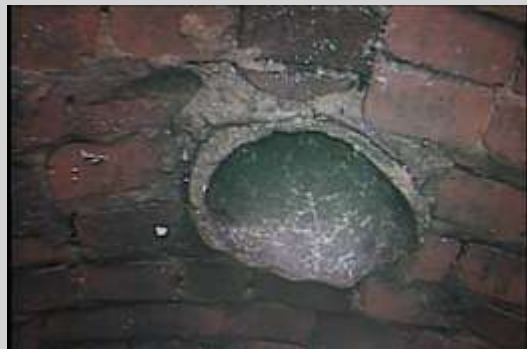
Pipe In @ 10 O'Clock

Infiltration: **Evidence**

Pipe Seal Cond: **Cracked**
